Success Story

Industry: Power Generation

Application: Industrial Fan Units

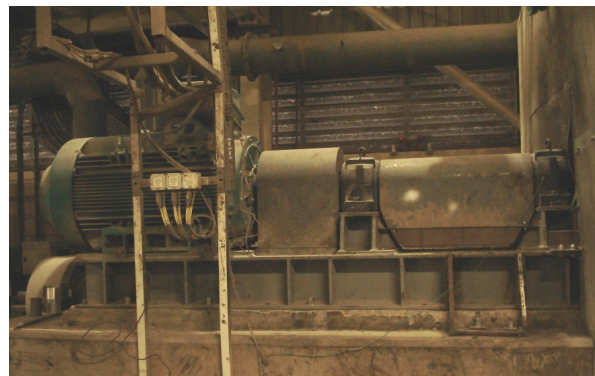
↑ Industrial Fan Unit

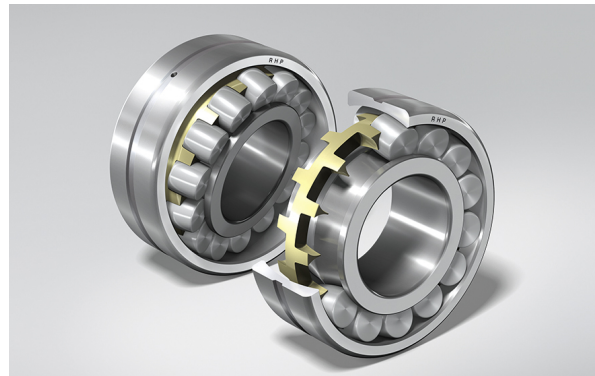
- Heat stabilised up to 200°C,
- One-piece machined brass cage
- Special ring tolerances to withstand vibration, shock loads & misalignment

↑ Spherical Roller Bearing with Brass Cage
