## Success Story

Industry: Quarrying, Mining and Construction

Application: Concrete Floor Manufacturing Unit

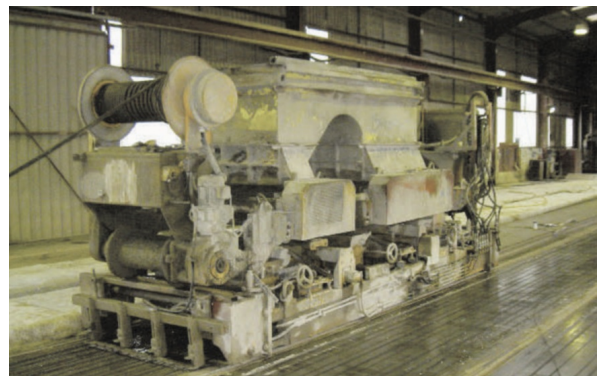
↑ Concrete Floor Manufacturing Unit

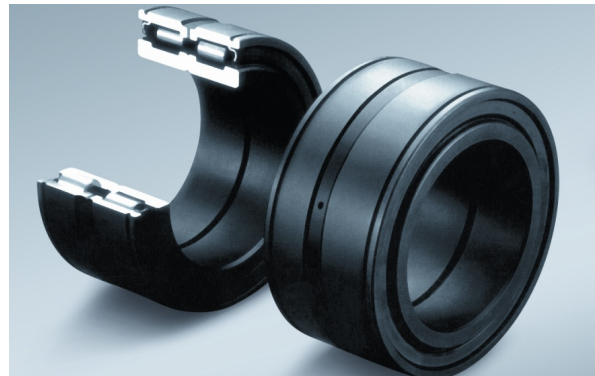
- Improved contact seals
- High load rating
- Highly corrosion resistant phosphate coating
- Easier grease re-lubrication due to inner and outer ring re-lubrication holes
- Bearings pre-greased with Lithium grease
- Can be fitted with DIN 471 snap rings
- Contact seals prevent ingress of foreign particles or water
- Increased radial and axial capability
- Re-lubrication holes for easy maintenance and grease replenishment
- Can be used in external environments due to phosphate coating
- Snap ring (DIN 471) can be applied to the outer ring

↑ Full complement Cylindrical Roller Bearing Unit with seals

- Investigation of failed bearings showed that the cause of failure was incorrect selection and ingress of contamination
- NSK conducted a machine design review and produced a new hub assembly proposal
- By incorporating NSK Full Compliment sealed bearing units, secured by circlips in the outer ring, the load rating was increased and the integral seals provided increased protection for the bearings
- The customer followed NSK design proposals and produced a new shaft and housing
- NSK also provided on site consultation detailing lubrication and assembly best practice
- Machine failures were reduced from 20 per year to zero.
