## Success Story

Industry: Textile and Leather

Application: Belt washer

### Introduction

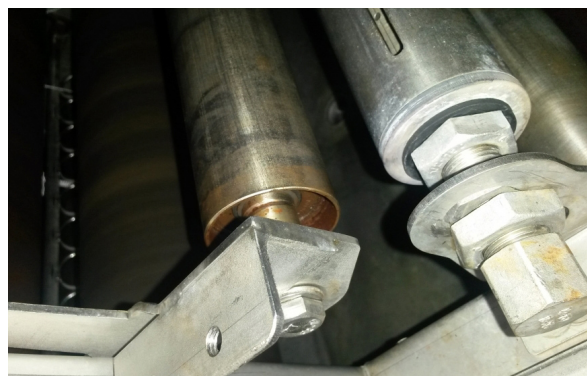
An international manufacturer of technical textile products was experiencing frequent bearing failure on a belt wash application. NSK carried out a Bearing Failure Analysis revealing ingress of water and chemicals leading to the bearing failures. NSK was asked to find a solution to this problem. A trial was agreed which resulted in an increase of bearing life.

↑ Belt washing application

- NSK engineering conducted a Bearing Failure Analysis showing ingress of water and chemicals into the bearing
- NSK required to replace the standard ball bearings with ball bearings Molded-Oil
- A trial was agreed which resulted in an increase of bearing life from 3 months to over 12 months
- The customer benefited from increased productivity and reduced maintenance costs
- No need for re-lubrication

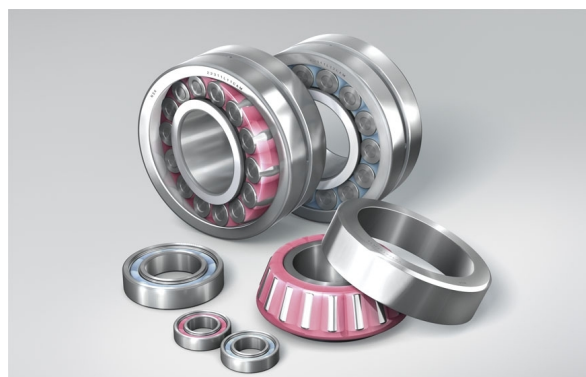
- Available for high speed applications
- Available in Ball Bearing, Spherical Roller Bearing and Tapered Roller Bearing types
- Rust-proof - Stainless steel for corrosive environments
- Ideal for applications where contact with liquids and chemicals is unavoidable
- Seals made from nitrile rubber
- Contact-seal type available in standard inventory for ball bearings
- Able to minimise oil leakage
- Longer service life
- No need for re-lubrication
- Smooth rotation of rolling elements

↑ Molded-Oil Bearing
