Success Story

Industry: Textile and Leather

Application: Belt washer

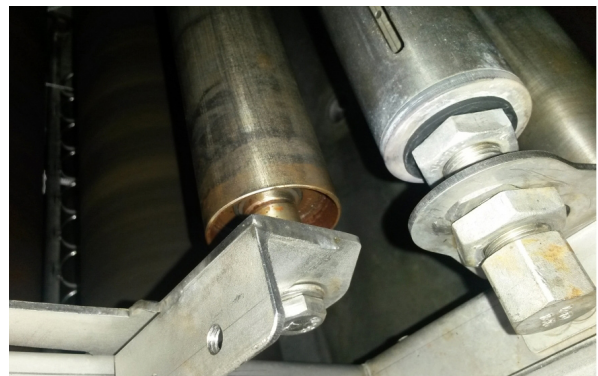
An international manufacturer of technical textile products was experiencing frequent bearing failure on a belt wash application. NSK carried out a Bearing Failure Analysis revealing ingress of water and chemicals leading to the bearing failures. NSK was asked to find a solution to this problem. A trial was agreed which resulted in an increase of bearing life.

↑ Belt washing application

- NSK engineering conducted a Bearing Failure Analysis showing ingress of water and chemicals into the bearing
- NSK required to replace the standard ball bearings with ball bearings Molded-Oil
- A trial was agreed which resulted in an increase of bearing life from 3 months to over 12 months
- The customer benefited from increased productivity and reduced maintenance costs
- No need for re-lubrication

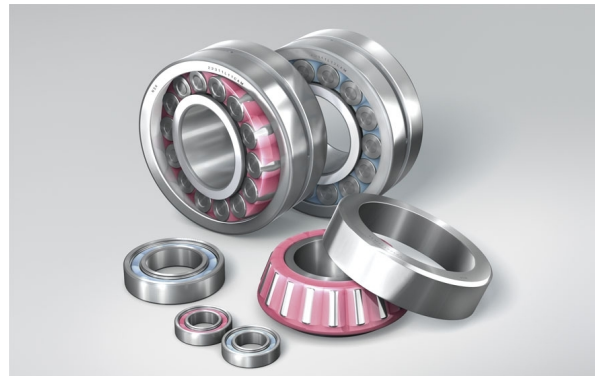
- Available for high speed applications
- Available in Ball Bearing, Spherical Roller Bearing and Tapered Roller Bearing types
- Rust-proof - Stainless steel for corrosive environments
- Ideal for applications where contact with liquids and chemicals is unavoidable
- Seals made from nitrile rubber
- Contact-seal type available in standard inventory for ball bearings
- Able to minimise oil leakage
- Longer service life
- No need for re-lubrication
- Smooth rotation of rolling elements

↑ Molded-Oil Bearing
