## Success Story

Industry: Quarrying, Mining and Construction

Application: Vibrating Drum

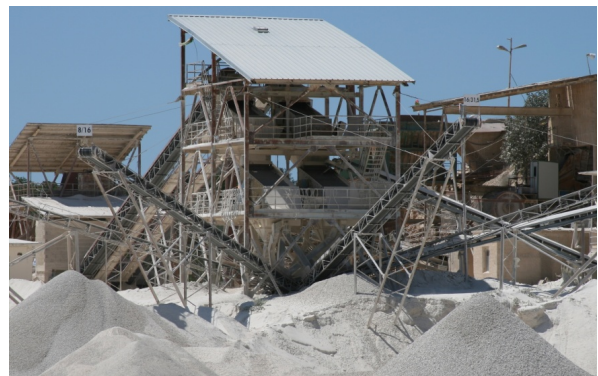
A company related to the Quarry & Mining industry was having frequent reliability problems with the bearing units assembled in a vibrating drum. These bearings worked under severe environments and were exposed to large amounts of sand, which often covered the units completely. Due to the nature of the application and its difficult access, the regularity and increasing cost of maintenance was an issue.

↑ Vibrating Drum

- NSK Engineers visited the site to assess the application
- Failed Bearing Analysis showed that fine sand particles were entering the bearing causing early failure
- A trial of Self-Lube triple lip sealed bearings resulted in life improvements 10 times than before

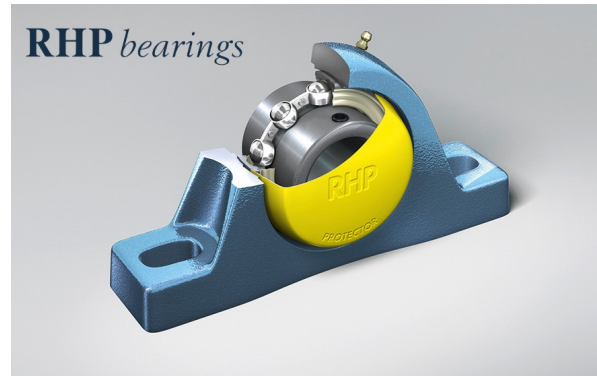
- Three high integrity nitrile seal lips with lubrication traps to stop ingress of contaminants
- High strength steel outer case resists impact to seal and provides a primary dust trap
- Available for both setscrew and eccentric locking collar inserts options
- Large size range offered, including imperial options
- Inserts interchangeable with standard items
- Longer bearing life through superior seal performance
- Extended re-lubrication intervals, greatly reducing maintenance costs and increased productivity of machinery
- Simple implementation; ready replacement for existing bearing units
- Mounting on the shaft with balled setscrews, providing much greater resistance to loosening

↑ Self-Lube
